Your Inspection Report

1234 Your House Dr
Your Town, TN

Monday, March 19, 2018

RE: Report No. 1006, v.21
1234 Your House Dr
Your Town, TN

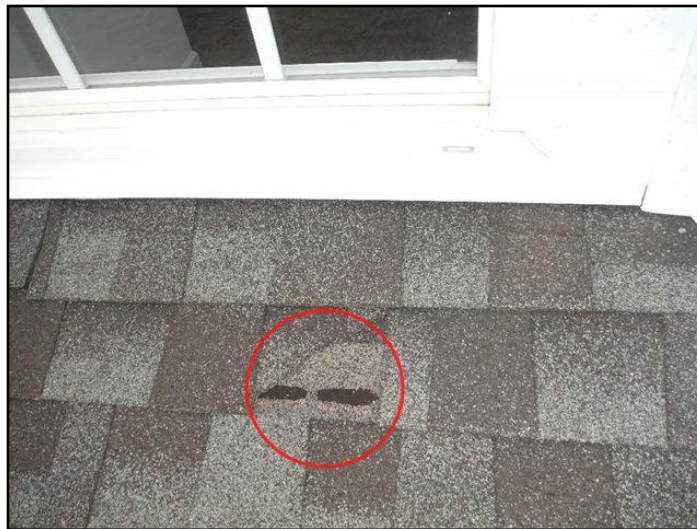
Condition: • Missing, loose or torn

There is one torn shingle by the left side front dormer. Otherwise the roof appears to be in good condition. Have a roofing professional investigate and repair as necessary.

Implication(s): Chance of water damage to contents, finishes and/or structure

Missing, loose or torn

Task: Repair

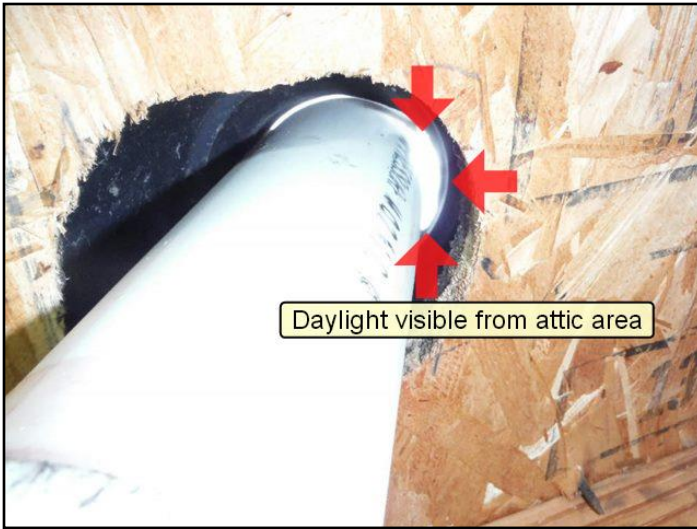
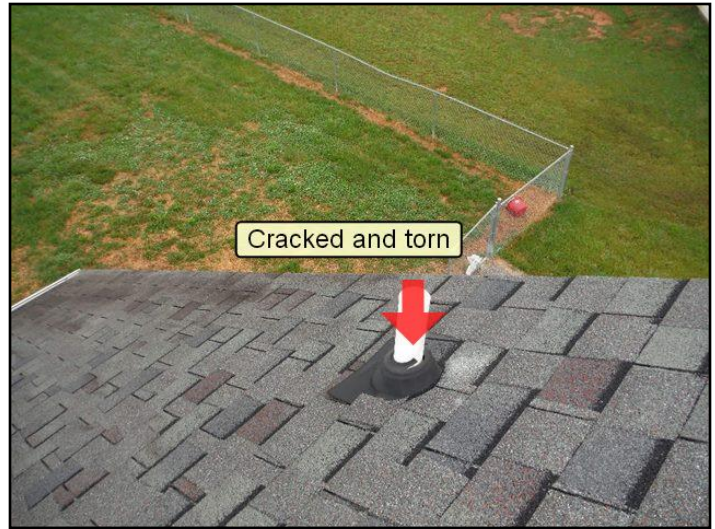
Condition: • Damage

The drain waste vent cover at the rear of the home is cracked and torn. This is a potential leak path for moisture into the attic area. Have this repaired or a new boot installed as determined by a roofing professional or handyman which corrects this issue for you.

Implication(s): Chance of water damage to contents, finishes and/or structure

Damage

Task: Repair or replace

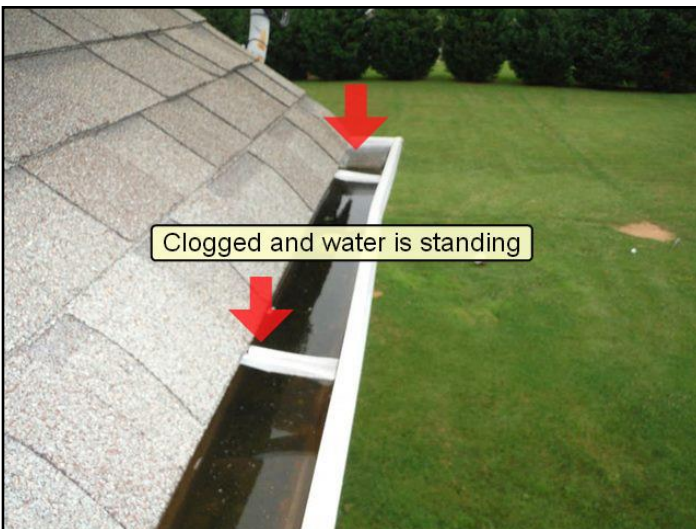
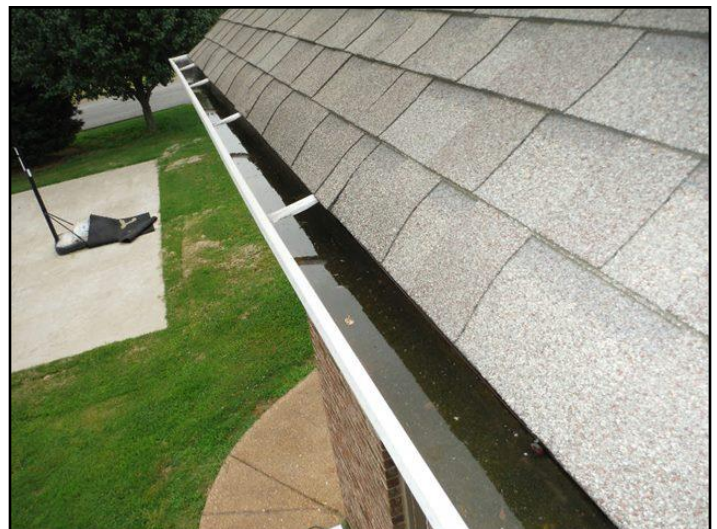
Condition: • Clogged

Implication(s): Chance of water damage to contents, finishes and/or structure

Clogged

Task: Clean

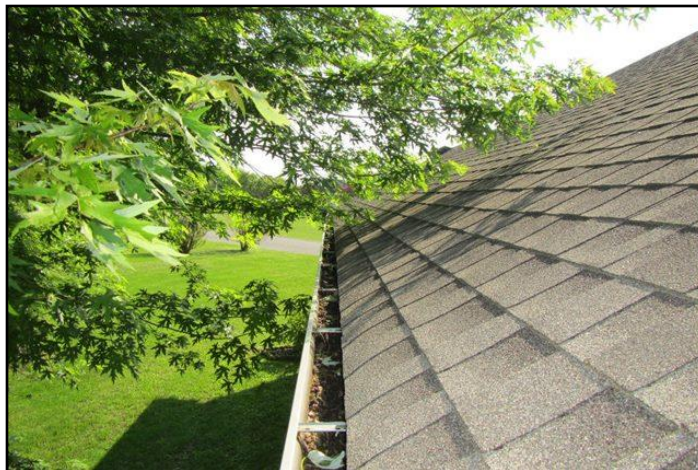
Condition: • Trees or shrubs too close to building

The limbs from the tree in the right side yard are hanging over the roof. This has the potential to damage the roof in a major storm should any limbs fall from the tree. Have a tree service trim these limbs back from the roof and home at least one foot.

Implication(s): Chance of water damage to contents, finishes and/or structure | Chance of pests entering building | Material deterioration

Trees or shrubs too close to building

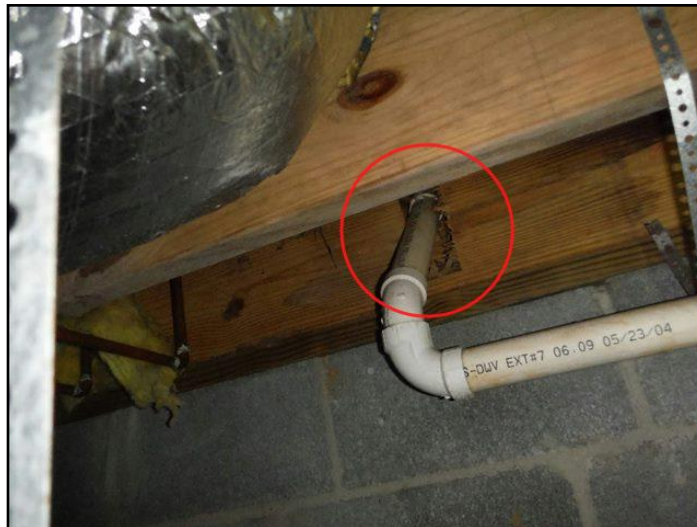
Condition: • Notches or holes

It would be beneficial to have a structural engineer or company investigate this to see if some form of blocking should be installed at this notched installation for support because the joist is over notched. Follow there recommendations for any repairs or installations.

Notches or holes

Task: Further evaluation

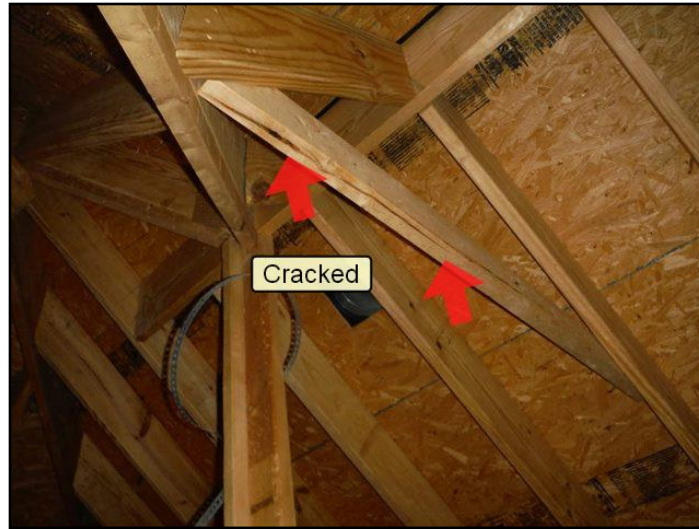
Condition: • Mechanical damage

This collar tie is cracked and should be replaced to avoid potential future issues should it break completely. A general contractor or handyman can replace this for you.

Mechanical damage

Task: Replace

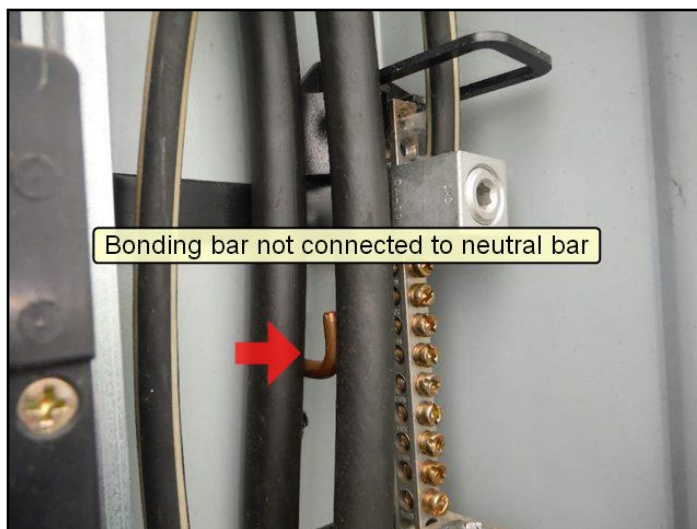
Condition: • Box not bonded to ground

The bonding bar is not installed in the neutral ground buss bar in the main electrical panel. This can lead to potential shock hazards. Have a licensed electrician investigate and repair as necessary.

Box not bonded to ground

Task: Repair

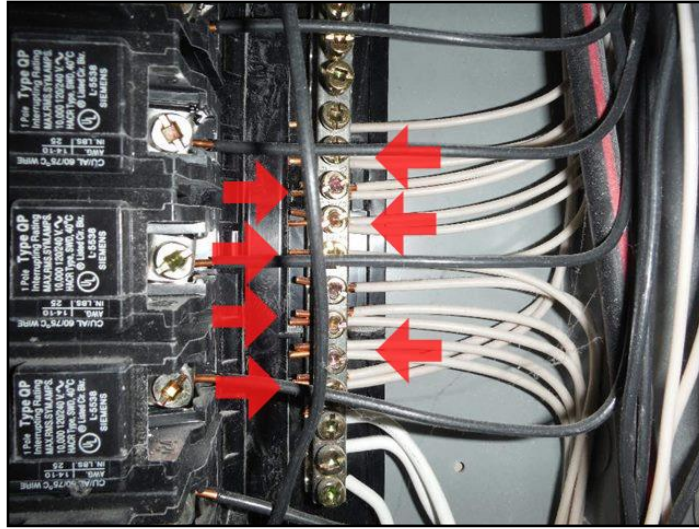
Condition: • Double taps

There are seven sets of double tapped neutrals in the sub-panel. This is a potential hazard. Each neutral wire should be under a single lug in this panel. A circuit can not be isolated with this type of double tap. Have a licensed electrician investigate and repair as necessary.

Implication(s): Fire hazard

Double taps

Task: Repair

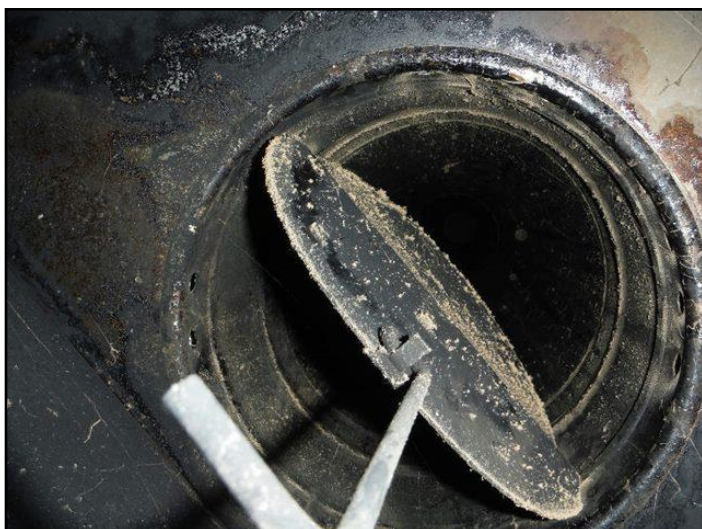
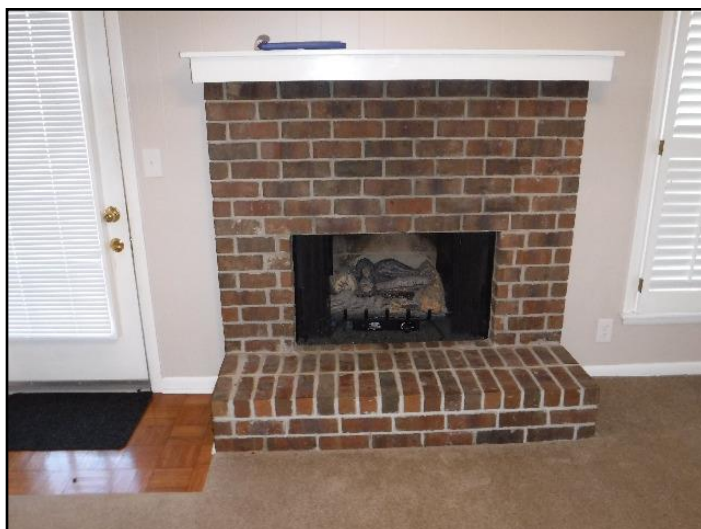
Condition: • Inspect (and/sweep if needed) before using

The wood burning fireplace and chimney should be inspected (a level 2 inspection) and cleaned as necessary by a chimney sweep prior to use. NOTE: A carbon monoxide detector should be installed in the home when a wood burning fireplace, gas water heater and a gas HVAC unit are present for safety reasons.

Implication(s): Fire hazard

Inspect (and/sweep if needed) before using

Task: Service clean

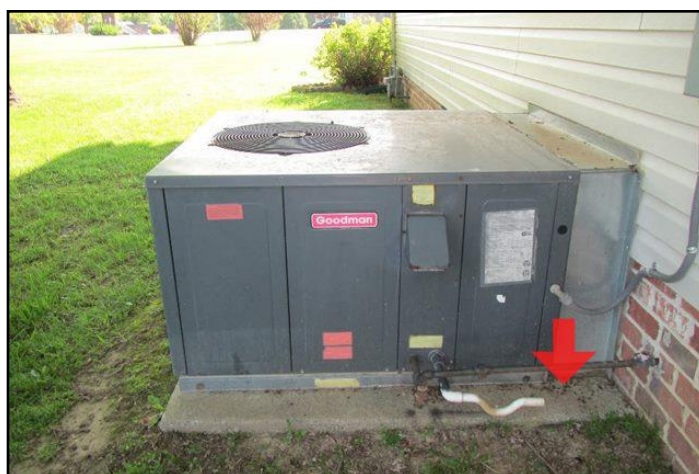
Condition: • Improper discharge point

The condensate drain trap exits toward the homes foundation. Have your HVAC technician repair this condition so the condensate will drain away from the house and not toward it.

Implication(s): Chance of water damage to contents, finishes and/or structure | Damage to equipment | Contaminants may enter building air

Improper discharge point

Task: Repair

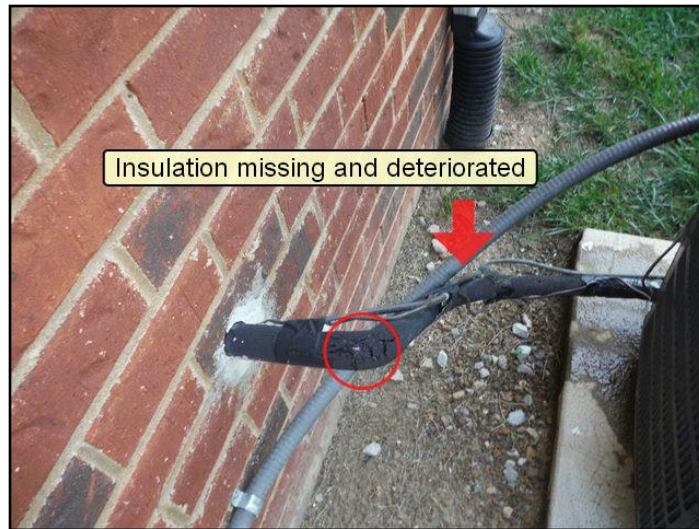
Condition: • Insulation - missing

The HVAC unit located in the right side yard has visual deterioration and missing insulation of the refrigerant line. This condition can reduce the efficiency of your cooling unit. Have your HVAC technician investigate and repair as necessary.

Missing insulation

Task: Repair or replace

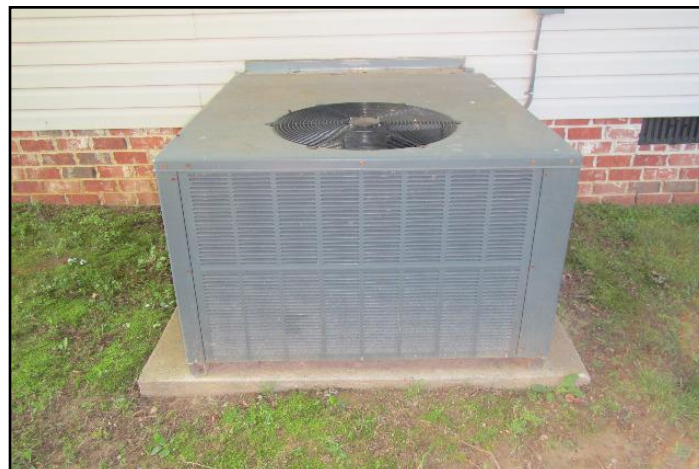
Condition: • Near end of life expectancy

The heat pump unit is approximately 10 years old and is nearing the end of its life expectancy. Typical life expectancy is 10 to 15 years. Make plans for the replacement of the unit now so it will not be a burden when it is time. I recommend having a HVAC technician examine, clean and service this unit for you prior to use due to the age. It performed without issue on the day of inspection.

Near end of life expectancy

Task: Further evaluation

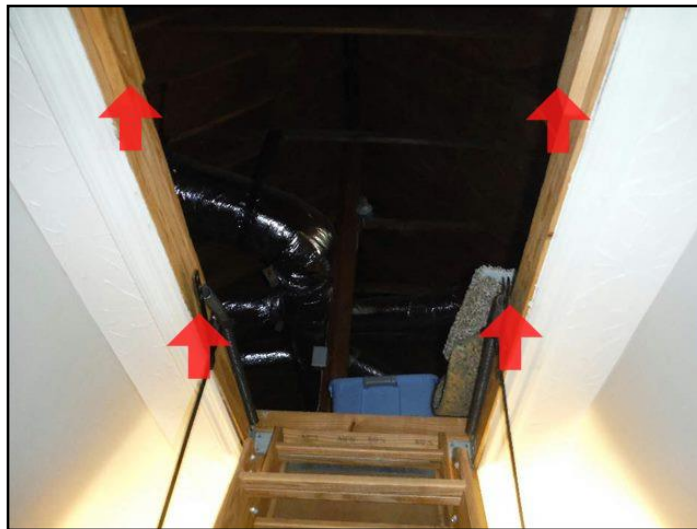
Condition: • Not insulated

The pulldown stairs for attic access does not have insulation. Installing insulation at this opening will reduce your heating and cooling costs and not allow warm and cool conditioned air into the attic space.

Not insulated

Task: Install

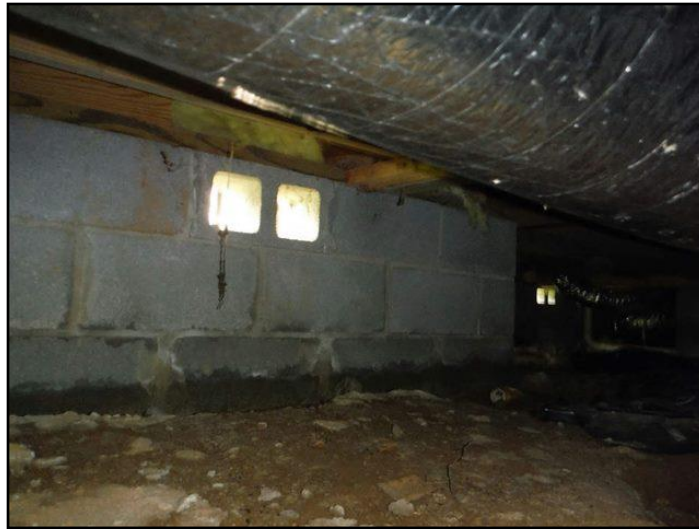
Condition: • No vapor barrier

Implication(s): Chance of condensation damage to finishes and/or structure

No vapor barrier

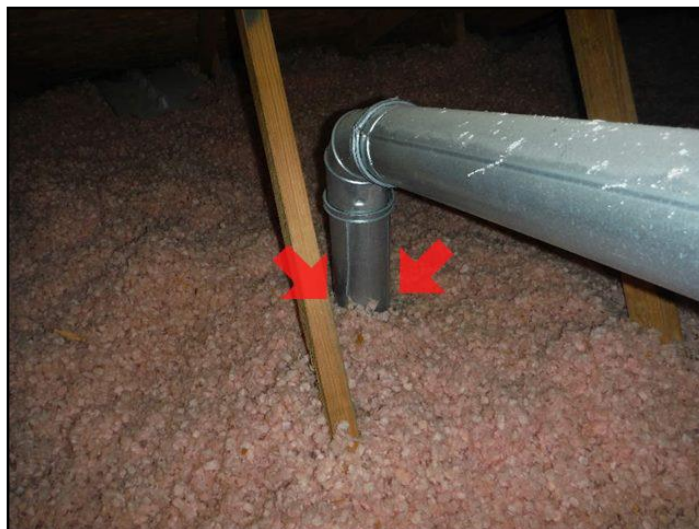
Condition: • Combustible clearance

There is no clearance to combustibles between various materials/debris and the gas water heater vent piping. There is a minimum clearance of inch on type B vent piping. Have a licensed plumber repair this installation miscue for you.

Implication(s): Fire hazard

Combustible clearance

Task: Repair

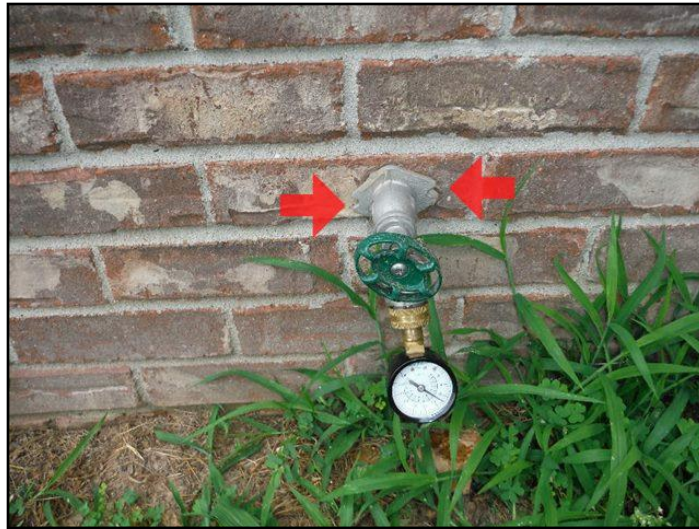
Condition: • Loose

The hose bibb located on the exterior wall at the rear of the home are not secured with fasteners. This loose condition can cause pipe damage when operating the hose bibb. Have a licensed plumber or handyman secure this hose bibb to the exterior wall.

Loose

Task: Repair

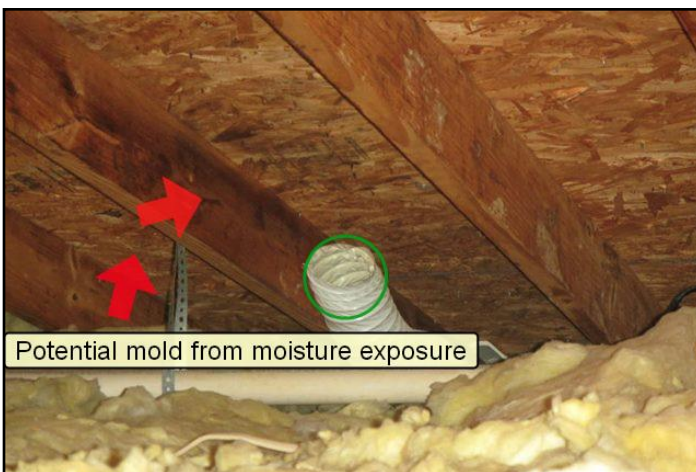
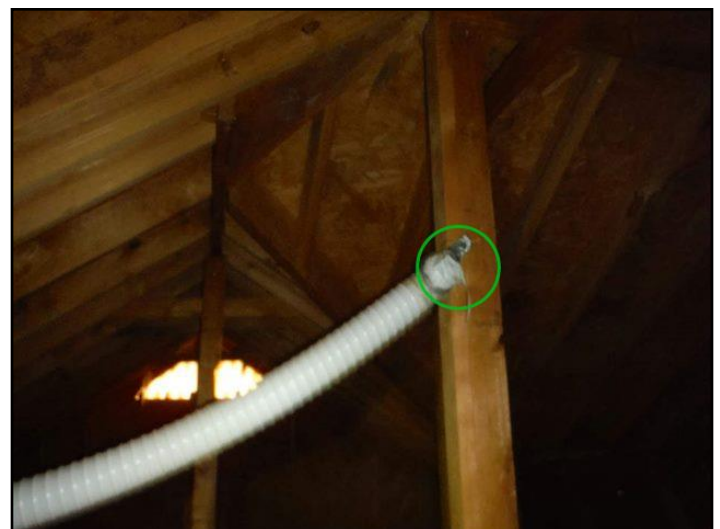
Condition: • Poor termination location

Both bathroom exhaust vent ducting exits into the attic area. The vents should exit to the exterior to avoid potential moisture intrusion into the attic space. Your general contractor, handyman or roofing company which installed this roof can assist in correcting this issue.

Implication(s): Chance of condensation damage to finishes and/or structure

Poor termination location

Task: Repair

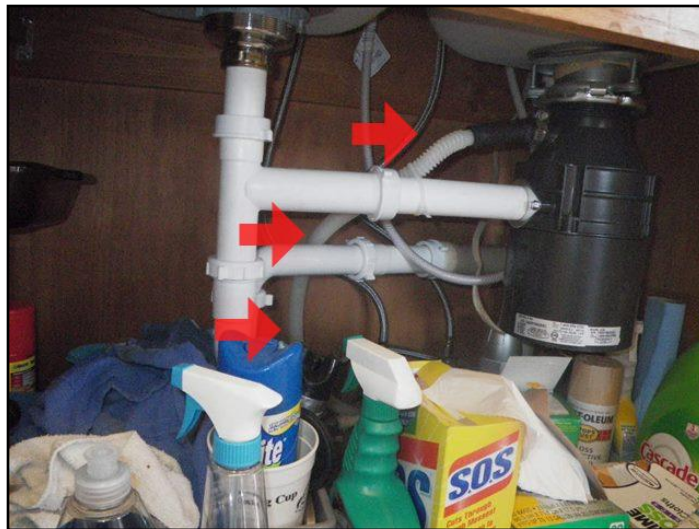
Condition: • Backflow prevention missing

Backflow prevention missing

Task: Install
